Continental Airlines, Inc.
Systems Engineering
600 Jefferson Blvd
Houston, TX 77002

Subject: B757 Inspection of Wire Bundles in Wing AFT Fairing – Proposed Rule

Reference: A/ Rules Docket No. FAA-2004-19540
B/ Boeing Service Bulletins 757-28A0073 & 757-280074
C/ NPRM Docket No. 2004-NM-110-AD

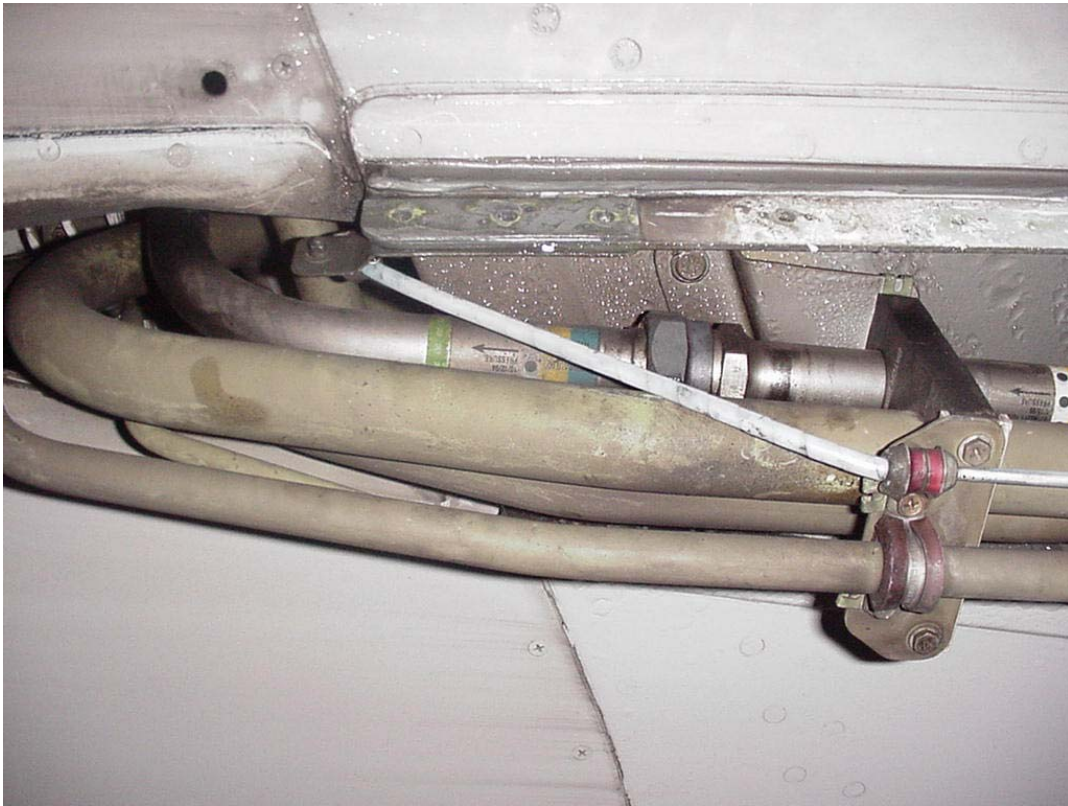
FIGURE 2

- The wiring for the right engine fuel shutoff valve in certain airplanes is found to be touching the hydraulic tubing and there is no provisioning to maintain proper separation. Refer to figure 2.
